Flood Control Project Maintenance
2018 Structure Summary Report
Overall Unit and Item Ratings

Turlock Irrigation District Gomes Lake

Gomes Lake Pumping Plant

Flood Control Project Maintenance**Unit Cover Sheet****2018 Pumping Plant Inspection Results****Turlock Irrigation District Gomes Lake**

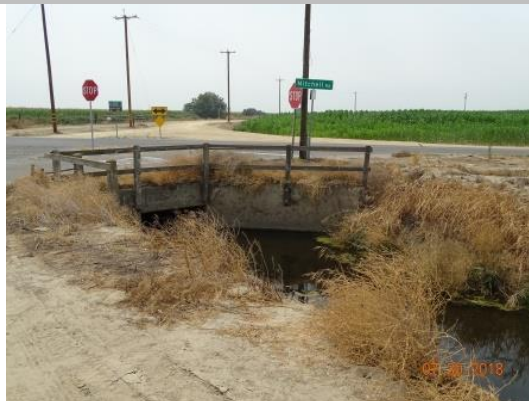
Photo 1 of 4 : ST_2018_NA0065_70_1_20180810_00021.jpg

View of inlet of siphon structure at corner of Mitchell Rd and Williams Ave. (2018)

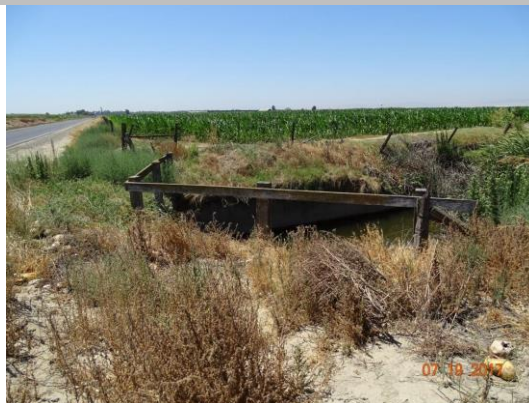
Photo 2 of 4 : ST_2018_NA0065_70_1_20180803_00002.jpg

View of the outlet of the structure looking from Mitchell Road. (2017)

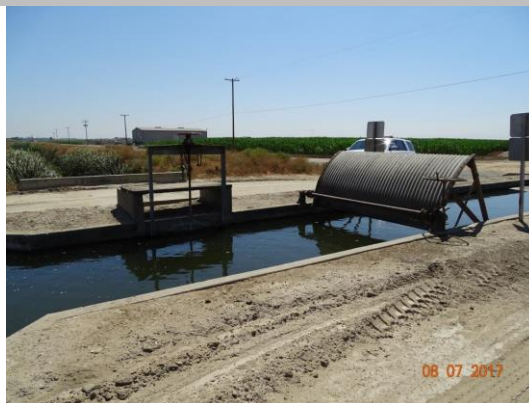
Photo 3 of 4 : ST_2018_NA0065_70_1_20180803_00003.jpg

View of the lateral 7 control gate upstream of the siphon structure. (37.394123, -120.940805) (2017)

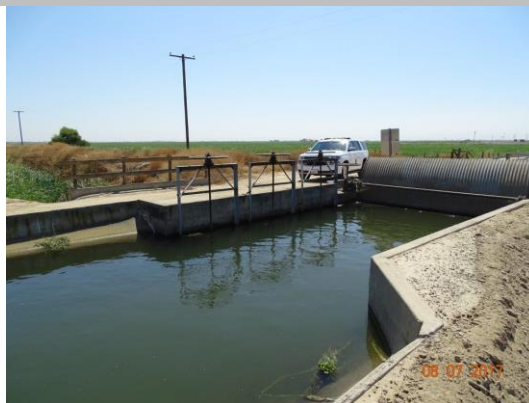
Photo 4 of 4 : ST_2018_NA0065_70_1_20180803_00004.jpg

View of the lateral 6 control gates upstream of the siphon structure.
(37.406061, -120.940602) (2017)

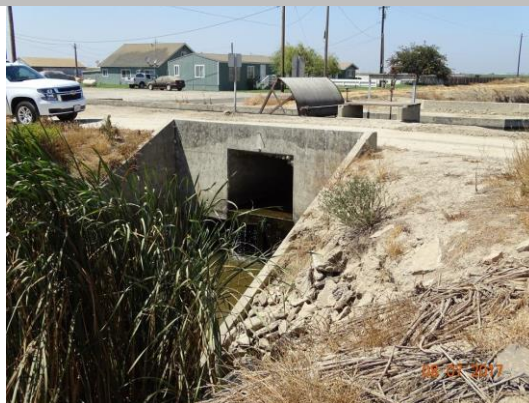
Photo 3 of 4 : ST_2018_NA0065_70_7_20180803_00011.jpg

View of the outlet culvert at the lateral 7 gate. (37.394123, -120.940805) (2017)

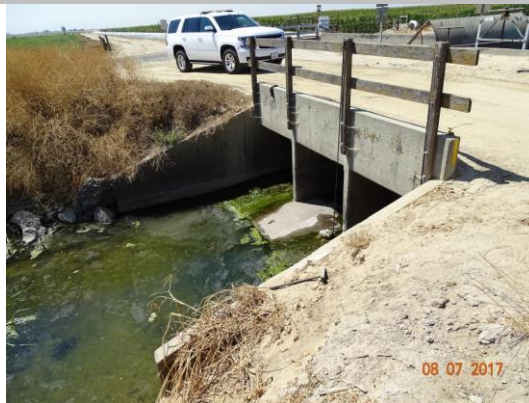
Photo 4 of 4 : ST_2018_NA0065_70_7_20180803_00012.jpg

View of the outlet culvert at the lateral 6 gates. (37.406061, -120.940602) (2017)

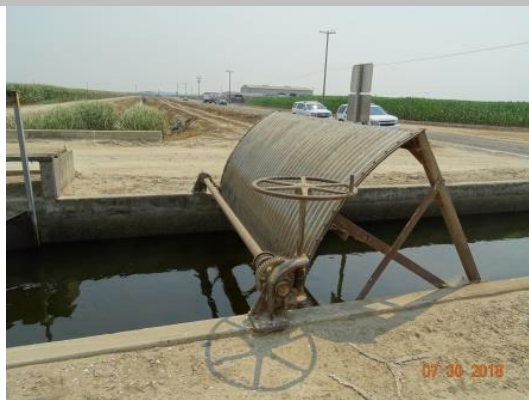
Photo 1 of 5 : ST_2018_NA0065_70_12_20180813_00028.jpg

View of the radial gate at lateral 7. (37.394123, -120.940805) (2018)

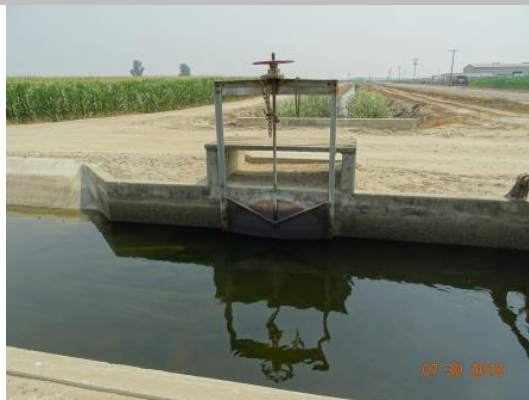
Photo 2 of 5 : ST_2018_NA0065_70_12_20180813_00027.jpg

View of the slide gate at lateral 7. (37.394123, -120.940805) (2018)

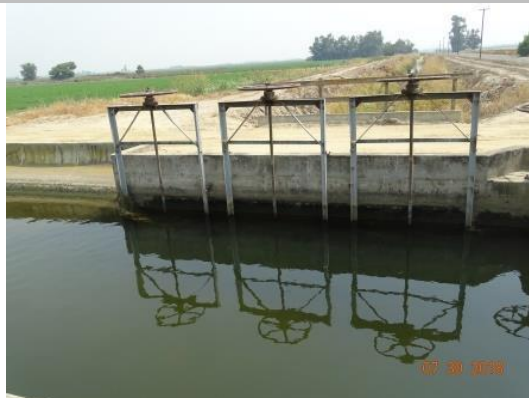
Photo 4 of 5 : ST_2018_NA0065_70_12_20180813_00031.jpg

View of the slide gates at lateral 6. (37.406061, -120.940602)
